Power MOSFET Failures in Automotive Applications

By **Kandarp Pandya, Klaus Pietrczak, Arthur Chiang, Greg Getzan**

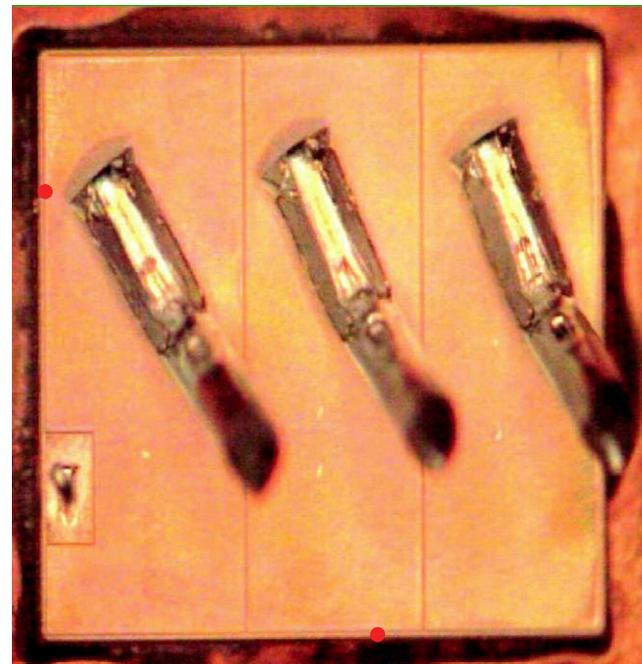
Failure analysis performed at MOSFET manufacturing facilities can provide further insights into the actual device failure mechanisms. Basic electrical tests can indicate gate-to-source, gate-to-drain, and drain-to-source leakages with low resistance values. Examples of systematic decapsulation of failed devices are shown in figures 2 to 7. It can be observed that failures occur in two areas of the MOSFET structure. One failure is from gate metal to drain poly and the other failure is from source metal to gate poly. The conclusion from the analysis is that some voltage transient occurs on the gate and leads to the failure.

Fig. 2 - Typical Failure Locations gate Metal to Drain Poly Short are located on the Periphery of the Device

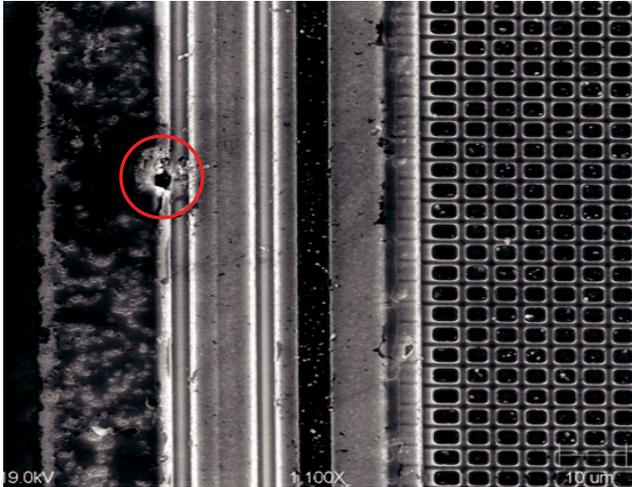
Fig. 3 - An Example of a Field return: Gate Metal to Drain Poly Short - Top View

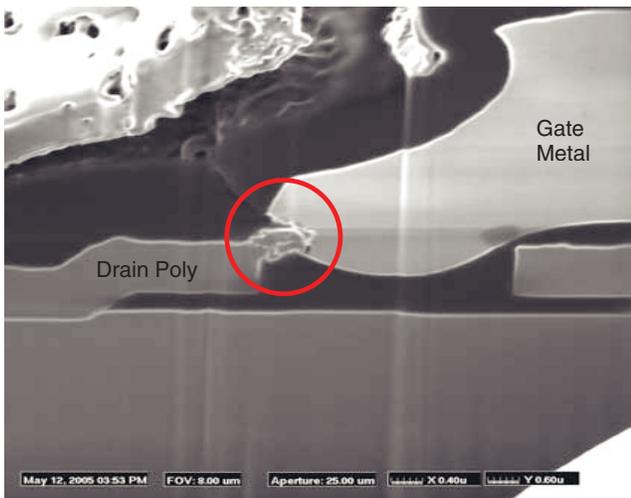
Fig. 4 - An Example of a Field return: Gate Metal to Drain Poly Short - X Section Short - Top View

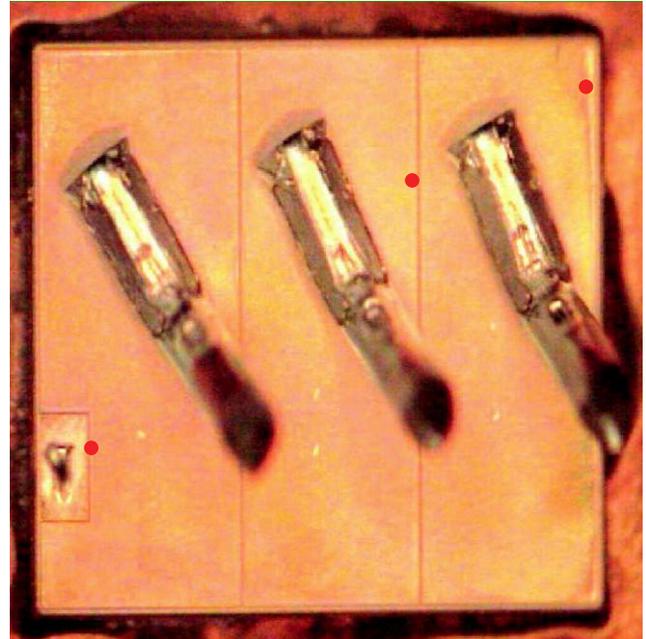
Fig. 5 - Possible Failure Locations of Source Metal to Gate Poly Short

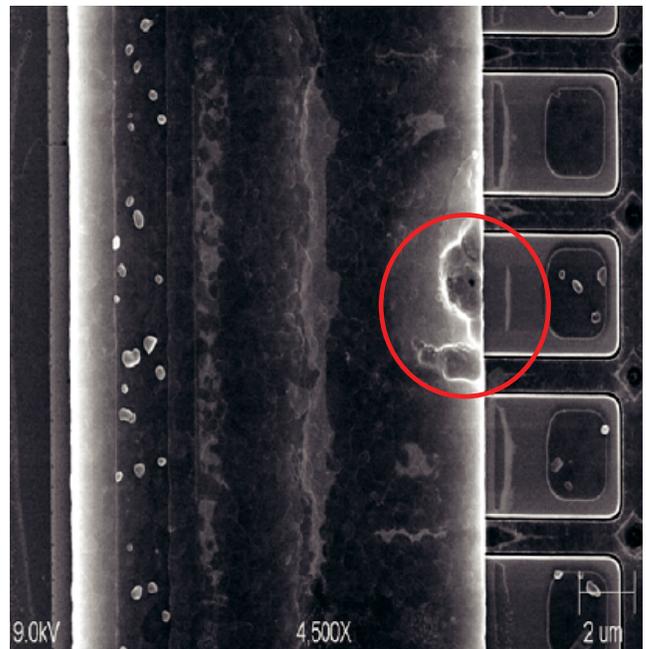
Fig. 6 - An Example of a Field return: Source Metal to Gate Poly Short - Top View

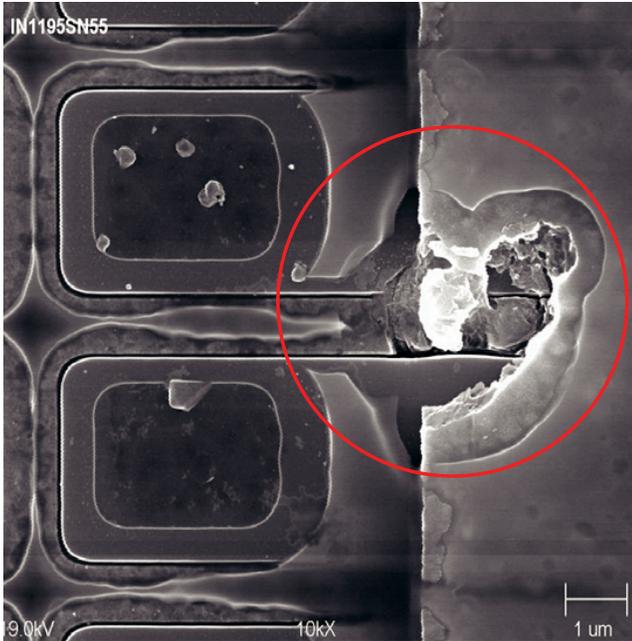
The transient test pulse definition and the corresponding failure analysis are shown in figures 8 to 13. The transient with open drain, $V_{GS} = 100\text{ V}$, and $150\ \mu\text{s}$ duration produces a failure signature close to field failure. Compare figures 17 and 7.

Fig. 7 - Another Example of a Field return: Source Metal to Gate Poly Short - Top View

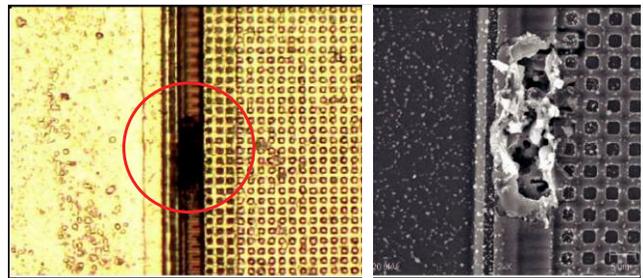
Figures 8 to 11 are photos of device failures generated from high-voltage ESD pulses. These failures are generated from human body model and machine model stressing. (Charged device model stressing was tried, but device failure could not be achieved at the limits of our testing.) The machine model failures seem to more closely resemble the failures we have seen from the field, indicating that perhaps some type of exposure to this model may be a pre-requisite to the field returns.

Fig. 11 - ESD Failure to Machine Model. Gate/Source Short

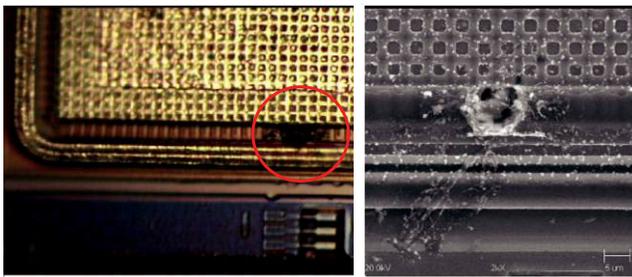
Fig. 8 - ESD Failure to Human Body Model. Gate/Drain/Source Short

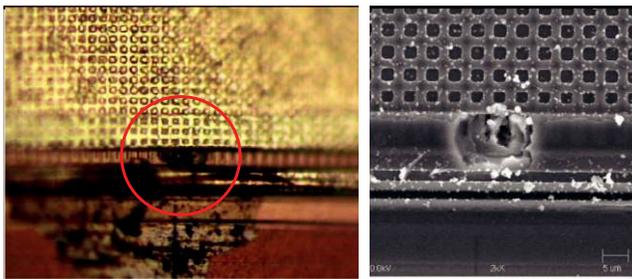
Fig. 9 - ESD Failure to Machine Model. Gate/Drain/Source Short

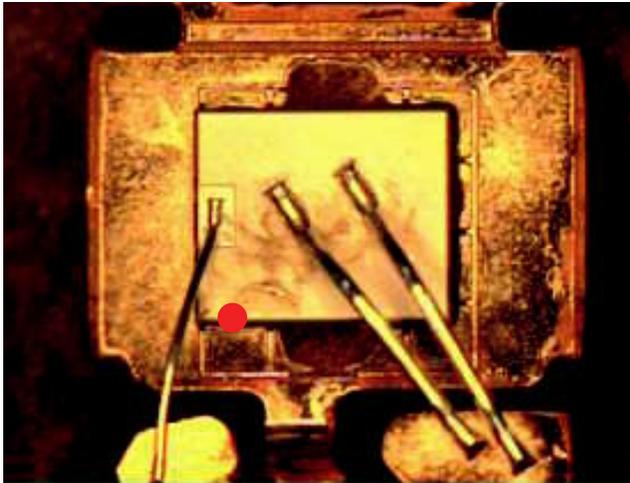
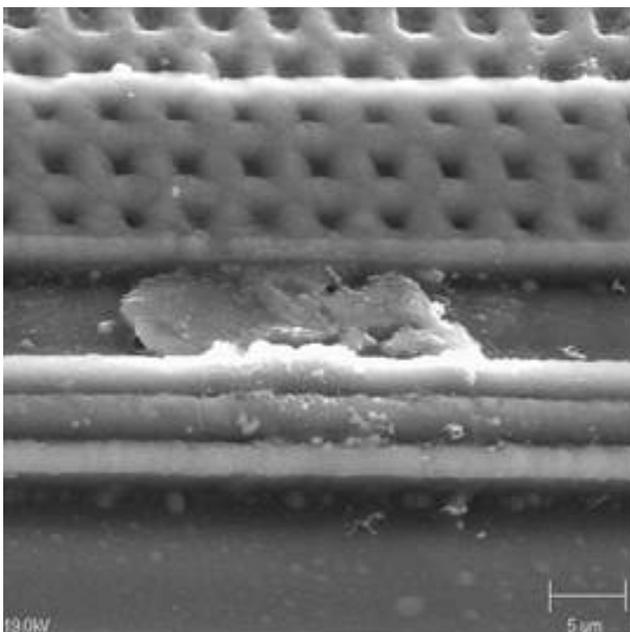
Fig. 13 - Severe burn Mark caused by Gate Oxide Rupture at Trench Poly to Poly Bus Intercept

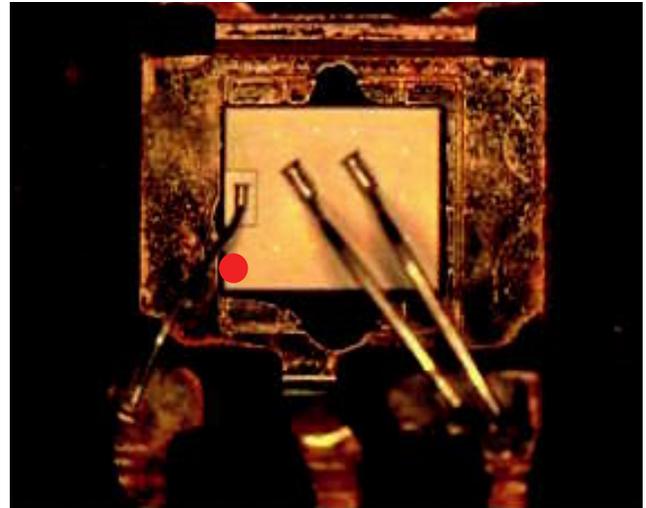
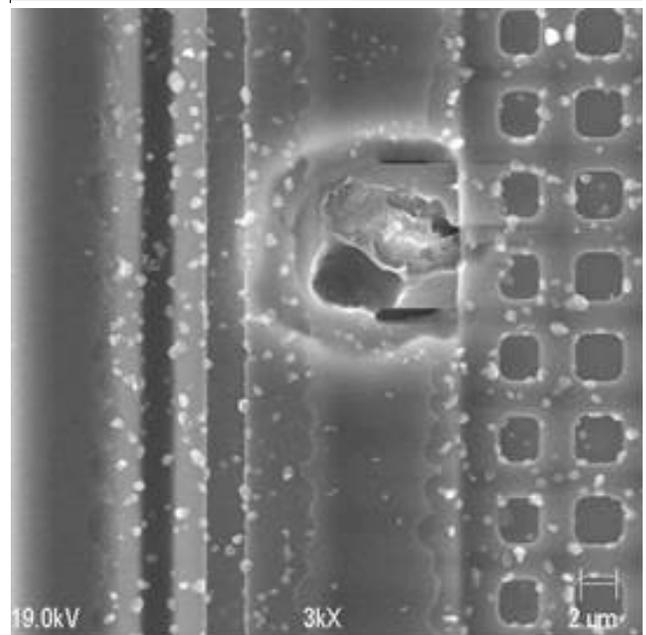
Fig. 15 - Severe burn Mark caused by Gate Oxide Rupture at Trench Poly to Poly Bus Intercept

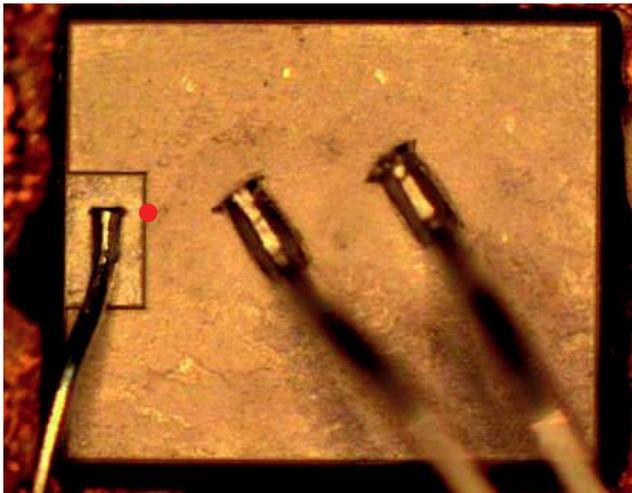
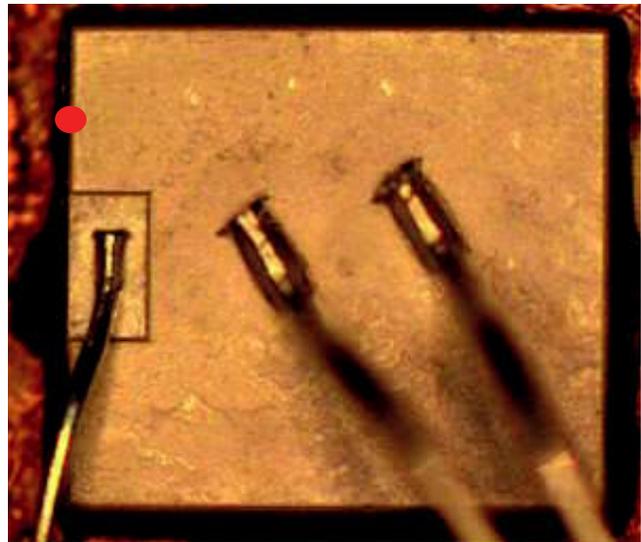
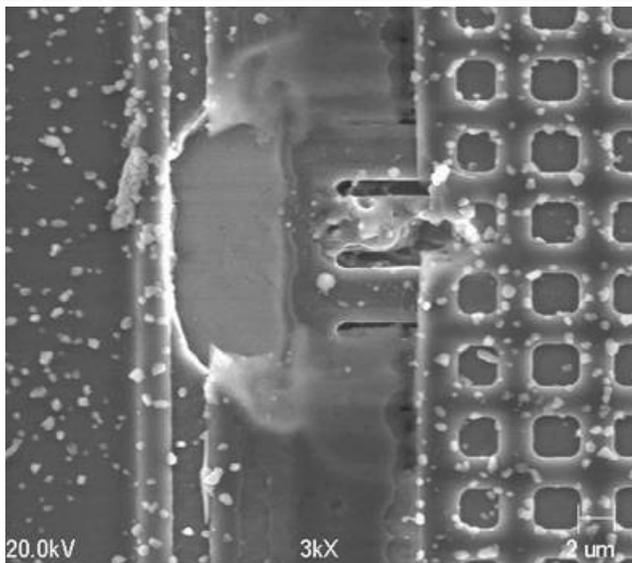
Fig. 17 - Severe burn Mark caused by Gate Oxide Rupture at Trench Poly to Poly Bus Intercept

- (1) The MOSFET manufacturer can increase the design margins while implementing improved techniques and new-generation materials. The attempt is to design and manufacture a more rugged part that can sustain such transients. These are long term solutions, requiring extensive evaluation and qualification.
- (2) The application system design can increase the electrical design margins to decrease the probability of device-damaging transients reaching the power MOSFETs.

- (3) The handling environments for devices can be re-evaluated to eliminate the potential for ESD damage (from equipment or humans).

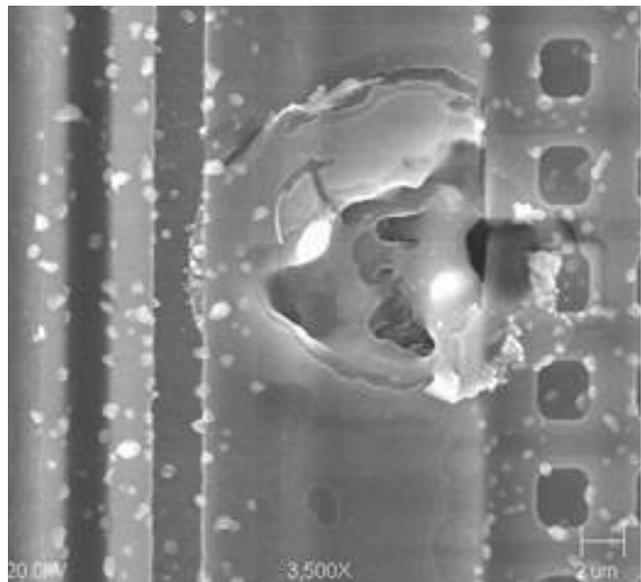
Four more samples were tested to establish repeatability. Results are shown in figure 18 to 25. We can observe that repeatability can be established to the extent that the failure signature is similar. However, the failure location varies.

Fig. 19 - Severe burn Mark caused by Gate Oxide Rupture at Trench Poly to Poly Bus Intercept

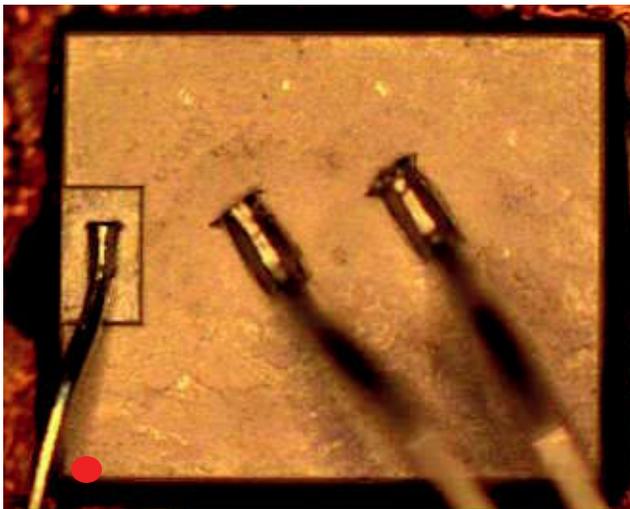
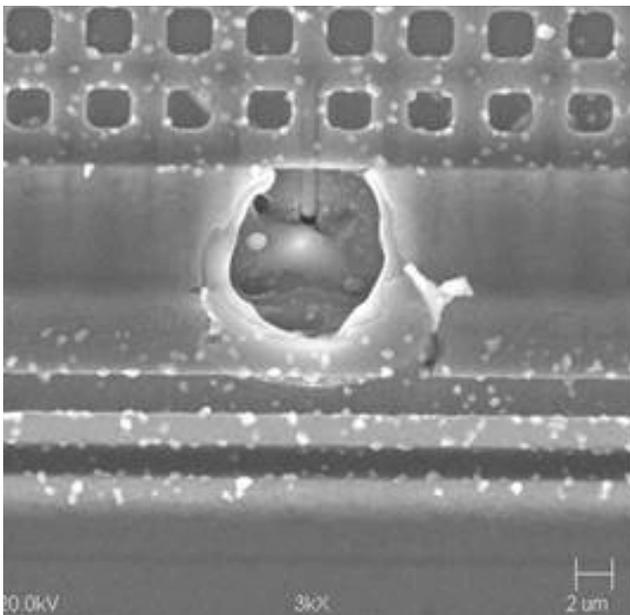
Fig. 21 - Severe Burn Mark caused by Gate Oxide Rupture at Trench Poly to Poly Bus Intercept

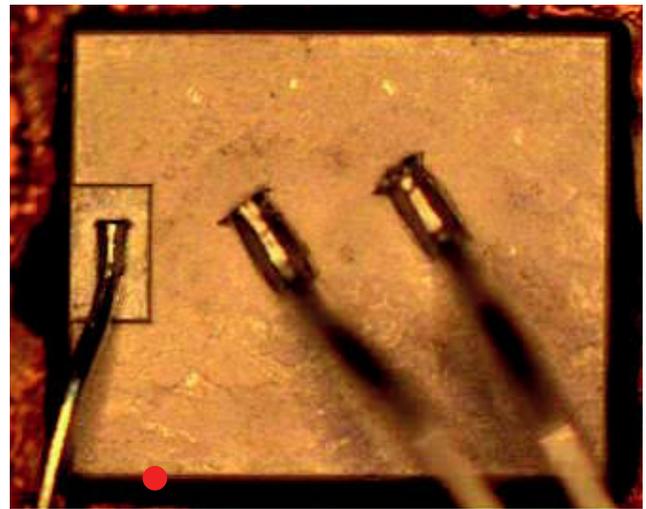
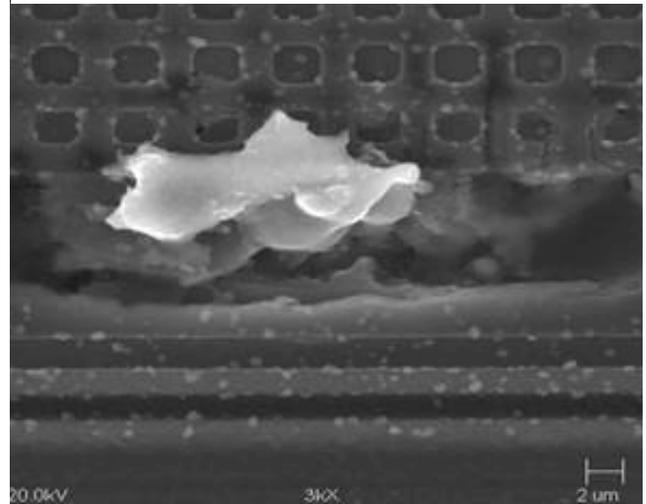
Fig. 23 - Severe burn mark caused by gate oxide rupture at trench poly to poly bus intercept

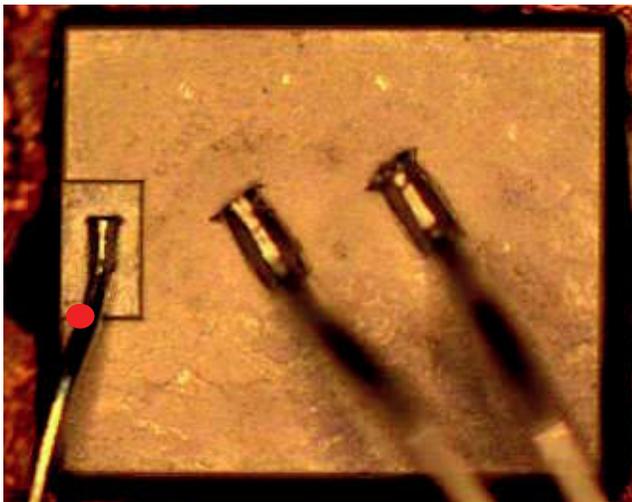
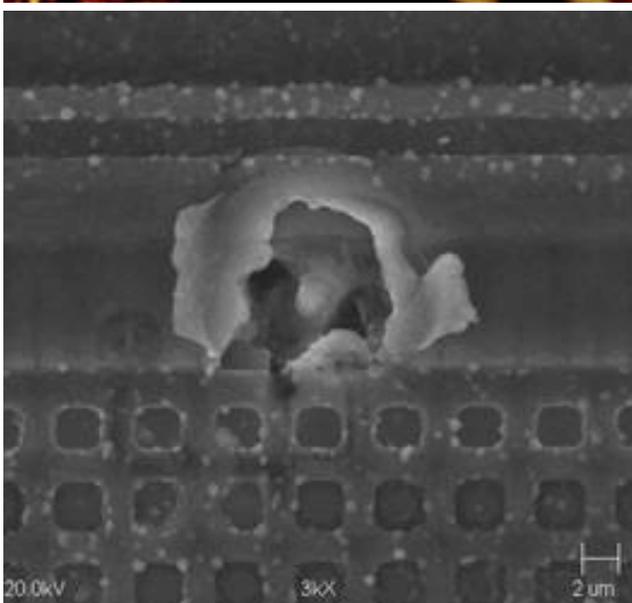
Fig. 25 - Severe burn Mark caused by Gate Oxide Rupture at Trench Poly to Poly Bus Intercept
