## IHLP Manufacturing Standards

#### Scope

This document was written for the purpose of helping customers better understand the IHLP product they are purchasing. It will give the customer an idea as to the type of cosmetic irregularities that may occur from time to time during the manufacturing of the component itself, or during their use of the component.

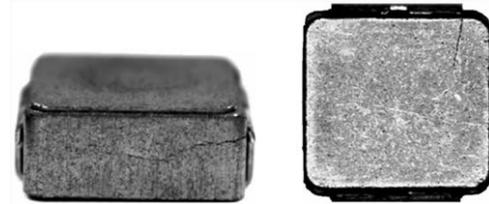
Terminal area crack, acceptable

Cracks coming from the top corner of the terminal are a normal occurrence and are caused by terminal expansion during curing operations.

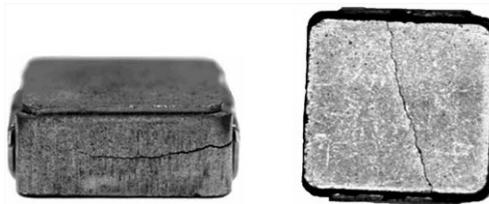
Minor crack, acceptable

Minor cracks are those that are visible without magnification but are not apparent without close inspection.

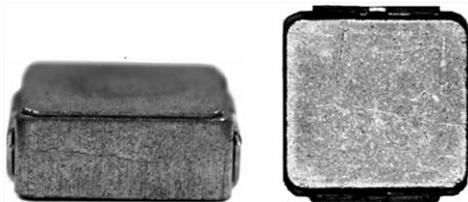
Moderate crack, rejectable

Moderate cracks are those that are obvious upon examination and continue across most of the component.

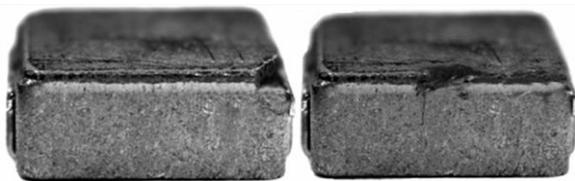
Chips typically occur on the edges and corners of the inductor body. They are slightly darker in color and rougher in appearance than the surrounding material.

#### Minor chipping, acceptable

Minor chips in the inductor body are those that are typically shallow imperfections that occur on the corners and edge of components. No coil wire or lead frame is showing and the chip does not affect the performance or reliability of the component.
