Power Metal Strip[®] Resistors

Application Note

The Benefit of Using a Three Sense Pin Design on Battery / Meter Shunt Resistors

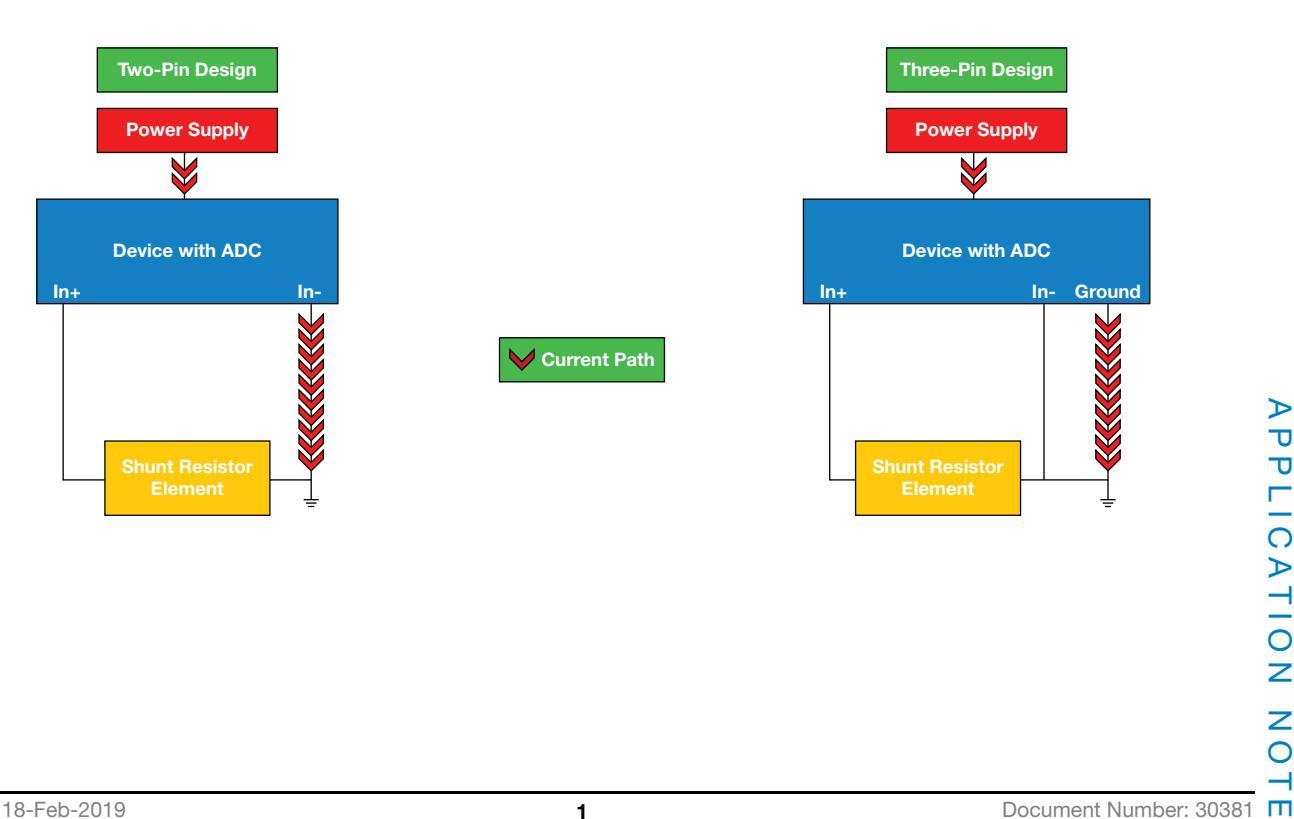
An example of a non-ideal design would be using a 2-pin shunt with one of the connections serving as a device ground as well as part of the sense circuit. This design does meet the requirement of a low differential between the ADC analog ground and the sense pin ground; however, it fails to limit current flow through the sense circuit. If all of the components for the sensing device use 10 mA of current when powered, then that same 10 mA is passing through the ground pin. If there is a minimal 1 m Ω of resistance in between the PCB pin connection and the shunt itself, it creates a 10 μ V drop. When sensing off a 100 μ \Omega shunt, a 10 µV drop equates to a 100 mA reading error. This error will vary part to part based on the PCB to shunt resistance and will vary within a single part over time based on the device power drawn under different operating modes. A designer should not attempt to correct for this error in software, as there are many factors that go into creating and changing it. The optimum way to eliminate all sources of error is through the use of a third ground pin on the shunt.
