### Degradation of IREDs

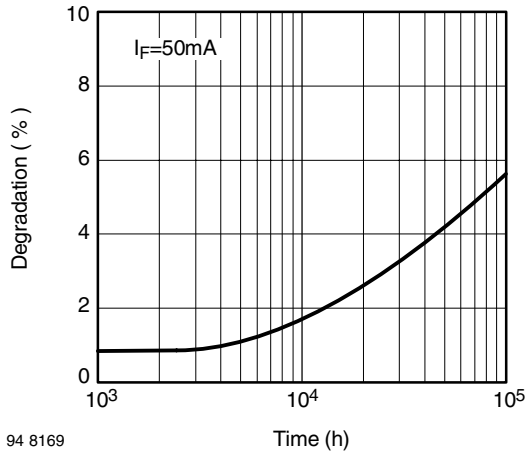
94 8169

The diagrams in figure 103 and figure 104 are based on electrical life tests, calculated with  $E_a = 0.8$  eV at  $T_j = 25^\circ\text{C}$ .

Figure 103. Average degradation of TSUS 5.

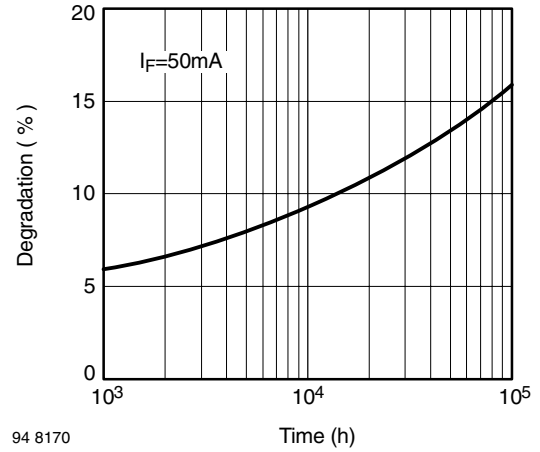
94 8170

Figure 104. Average degradation of TSHA 5.
